HUGHES SERVICE INFORMATION LETTER

LETTER NO. L-70

SUBJECT: LYCOMING SERVICE BULLETIN NO. 336B, DATED JUNE 19, 1972

RE: PERIODIC INSPECTION AND LUBRICATION OF MAGNETO DISTRIBUTOR BUSHING; PERIODIC PARTS REPLACEMENT OF LEFT MAGNETO

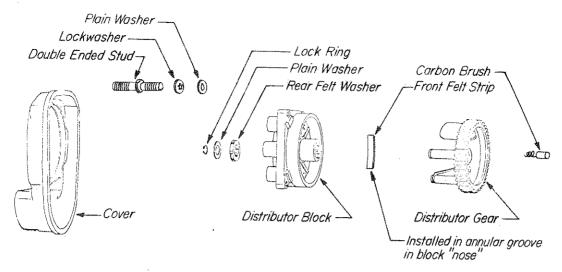
Figure 2. Partial Exploded View Showing Relative Location of Parts

- 6. Separate the distributor block and gear by removing lock ring. See figure 2.
- 7. Carefully inspect distributor gear for cracks, chipping or excessive tooth wear. Look for a concentration of yellow discoloration on the molding compound near its point of attachment to the shaft. (This could mean overheating has occurred in this area.) Observe shaft for discoloration or galling. (Shaft surface should be silver bright.) Gear exhibiting any of the above should be replaced.
