NOTICE NO. N-140 DATE 1 Sep 1976

SUBJECT: FIELD MODIFICATION - FUSELAGE FRAME ASSEMBLY

MODELS AFFECTED:

All Model 269A/TH-55A/A-1/B Helicopters:

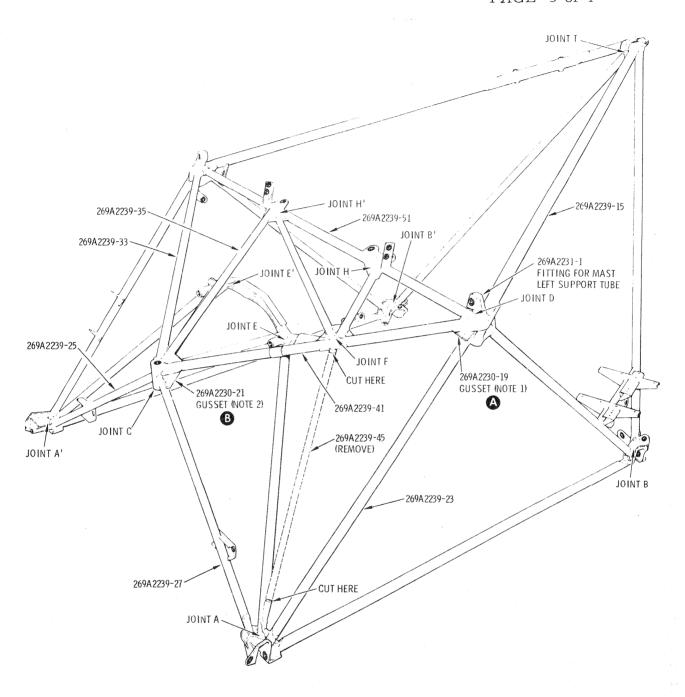
Figure 1. Modification - Fuselage Frame Assembly (Sheet 1 of 2)

consists primarily of removing the existing 269A2239-45 vertical support frame tube on the left-hand side of the fuselage frame, and welding support gussets in place at each end of the adjacent longitudinal frame tubes to accommodate the resulting bending loads. The field modification is recommended at removal of engine from helicopter. It is to be noted that there is no reduction of payload (with or without the cargo hook) with the

- 1. GUSSET TO BE IN PLANE OF CENTERLINES OF 269A2239-41 AND 269A2239-23 FRAME TUBES.
- 2. GUSSET TO BE IN PLANE OF CENTERLINES OF 269A2239-41 AND 269A2239-27 FRAME TUBES.

- a. Using metal cutting saw, remove 269A2239-45 vertical support frame tube as close as possible at Joint A and Joint F. (See Figure 1; also refer to Basic HMI for center frame section jig points.)
- b. Clean and treat exposed ends of tube and touch up with primer and paint for corrosion protection, per Section 2 of Basic HMI.
- c. Weld 269A2230-19 gusset in place at Joint D as shown in Figure 1; weld 269A2230-21 gusset in place at Joint C as shown. (Heliarc Welding Process preferred. Reference FAA AC 43.13-1A.)
 - d. Prime and paint gussets as required, per Section 2 of Basic HMI.

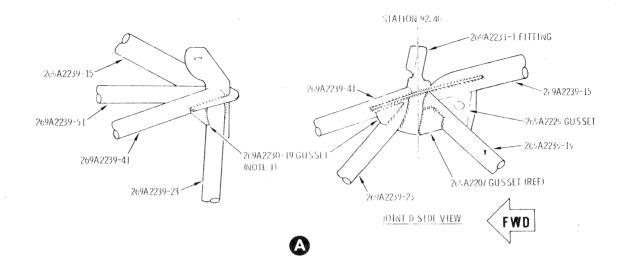
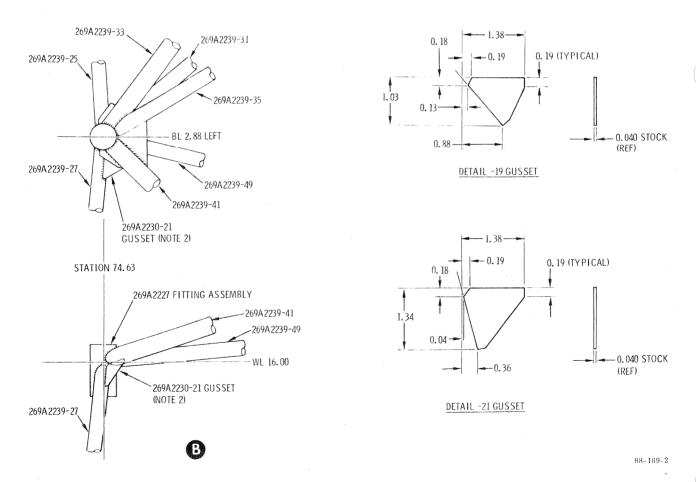
Figure 1. Modification - Fuselage Frame Assembly (Sheet 2 of 2)

*See Figure 1, detail -19 and -21 for field fabrication
